Safety Alert

Petroleum and Gas Inspectorate

Safety Alert No. 48
22 June 2011

Loss of well control

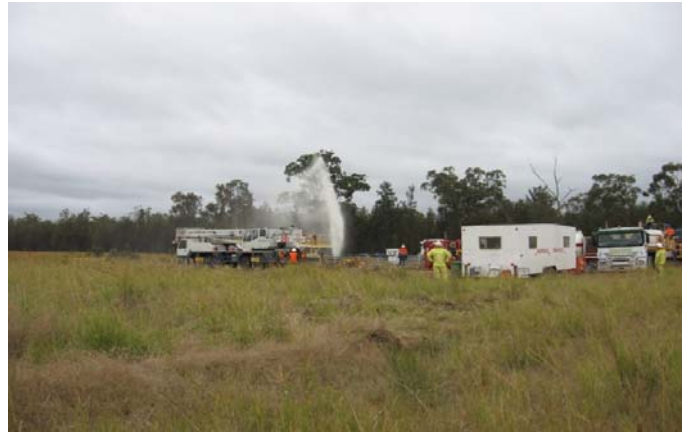
The rig crew were preparing to remove the top of the well head in order to nipple-up the 11" annular blow out preventer (BOP). The driller observed that the well was 'sucking' and interpreted this to mean that the well was dead. The driller removed the 3 1/2" EUE well-head cap from the top of the hanger. It was at this point that the well started to flow water with increasing intensity. The crew pumped water into the side-outlet in an unsuccessful attempt to kill the well. An uncontrolled mixture of water and gas flowed to a height above 15 metres.

The well was safely capped 24 hours after the initial gas release, with no injuries or equipment damage. The incident is still under investigation by the Petroleum and Gas Inspectorate but findings from the operator's investigation and preliminary findings from the Inspectorate's investigation are given below.

- A well-site handover between the tenure operator and the drilling contractor had not been completed.
- A well-completion plan was not followed.
- Contractor assurance checks by the tenure operator were inadequate.

- Supervision of contractor by tenure operator was inadequate.
- No well-pressure monitoring equipment had been installed.
- The rig crew wrongly assumed a 'sucking' well was a 'dead' well.

- The size of 'stab in valves' on site was incorrect.
- The on-site contractor Safety Management Plan was inadequate.
- There were no on-site procedures for this type of well completion.

- The well-head design, without specialist tools (not on site), requires opening the well to the atmosphere to install BOP, providing only one means of well control (water pressure).

- No calculations were completed to determine the volume of the hole before starting operations.
- There was poor communication between different business areas — i.e. despite the risk of completing this type of well being previously identified, insufficient controls had been put in place.

- The influence of surrounding production wells was not taken into consideration when undertaking completions — depletion from nearby producing wells decreased water pressure in deeper coal seams in the well, allowing gas and water from upper coal seams to flow into the well bore.

1. That tenure operators conduct detailed contractor assurance as part of their contractual process.
2. That contractor management systems are reviewed and fully implemented.

3. That the CSG operator and production, completion and drilling contractors conduct combined risk assessments or have systems to communicate risk assessments to ensure there are adequate controls to eliminate risk of unwanted events.

4. That all well-completion risk assessments and procedures be reviewed to ensure impact of nearby wells has been adequately considered.
5. That standard operating procedures for well completion be reviewed.

6. That policies and procedures detail when specialist well-control equipment (including tools) is likely to be required.
7. That workers are adequately trained in well control and installation/removal of the well equipment in order to install BOP.

8. That well-head design be reviewed and all well heads that have no fixed hard barrier control be identified.
9. That risks for those wells that do not have fixed hard barrier pressure control be reassessed and a hierarchy of controls be used to ensure the risks are as low as practicable.

10. That all equipment used to control a well be fit for purpose.
11. That there be systems in place to calculate well volume.
12. That a process for monitoring fluid levels and ensuring that redundancy fluids are readily available be implemented.

13. That consideration be given to installing equipment to monitor well-casing pressure, such as calibrated pressure gauges.
14. That emergency procedures be in place before conducting completion, or work over, activities on a well.
