Explosives Inspectorate

Safety Alert No. 48 | 7 October 2011

Forklift rollover while handling ammonium nitrate

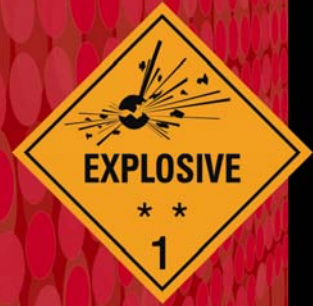
A forklift operator was removing a 1.2 tonne torn bulka bag of ammonium nitrate from a loaded semitrailer when the semitrailer moved forward.

The forklift truck was pulled over onto its side. There was also an ammonium nitrate spill.

1. Safety management systems and standard operating procedures should be reviewed to ensure that there is clear leadership and control of operations, and that directives are effectively communicated.
2. Emergency response plans should be clearly understood before activities are communicated.
3. Licence holders should check that approved and documented systems are followed, and records kept.
4. Standard operating procedures should be regularly reviewed, audited and verified.
