Safety Alert No. 51 | 18 October 2011

## Detonators initiated at scrap metal recyclers

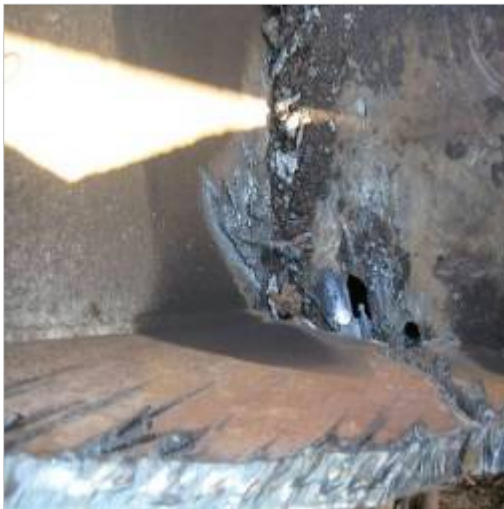
A steel coal stacker unit was being dismantled at a scrap metal yard by an operator using oxy cutting equipment when **3 out of 6 detonators inside the stacker unit exploded**. The operator, who was wearing protective clothing, was showered with detonator casing fragments but was not injured.

Figure 1. Damage to stacker unit from detonator explosion

1. All plant, equipment and vehicles used in connection with explosives must be certified free from explosives when being decommissioned.
2. The blast area and associated equipment must be certified free from explosives before disposal.
3. Anyone who certifies items as free from explosives must advise recyclers and other disposal facilities that they have been declared free from explosives. A certificate must be provided.
4. All licence holders and contractors should ensure that safety management systems and security plans address the decommissioning of plant, equipment, vehicles and demolition.
5. All licence holders and contractors should ensure that these procedures are followed and records are kept.

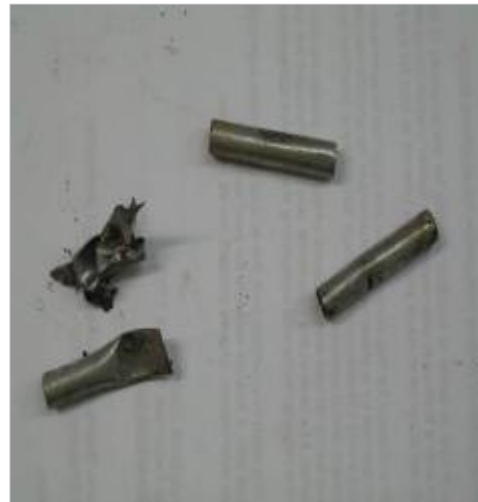
Figure 2. Recovered detonators
