Significant Incident Report

Significant Incident Report No. 78
10 August 2011

Longwall shearer frictional ignition hazard

Mine type: Underground coal mine — longwall

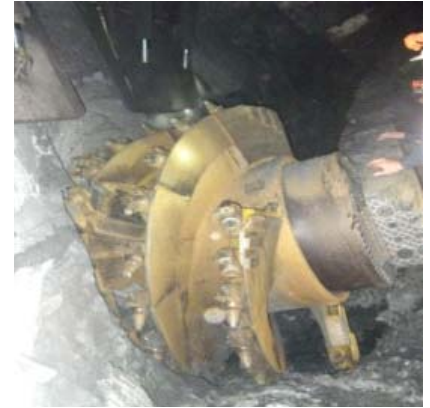
Incident: While cutting into an igneous rock intrusion, a damaged coal-cutting shearer (see photo right) created sparks that could have caused an ignition.

Hazard: Potential ignition of methane gas or coal dust.

- Material in the intrusion was much harder than the coal, resulting in increased wear on the shearer and picks.
- The operator did not notice the damage to the cutting equipment.
- The possible consequences of continued cutting with damaged equipment were not identified.
- There was poor communication of, and lack of adherence to, the drum pick inspection regime.
- The management direction to the crew—i.e. to continue cutting to position the shearer at the maingate for maintenance—was not communicated to the coal mine Deputy.

1. Quantify the inspection regime and monitor use of inspection sheets, records of inspections and records of any damaged equipment changed out.
2. Increase frequency of cutting drum inspections when intersecting intrusions.
3. Implement appropriate controls for mining through methane drainage holes.
4. Ensure the appointed ERZ Controller is on the longwall face during intrusion intersection.
5. Before intersecting intrusions, conduct longwall crew training on additional hazards expected.
6. Conduct face-to-face handovers.

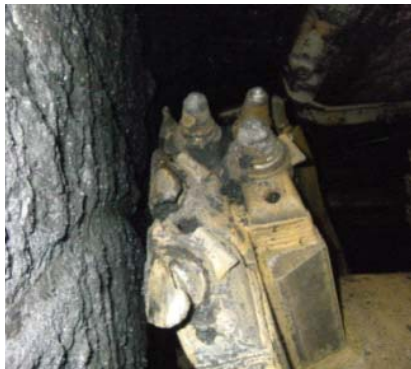
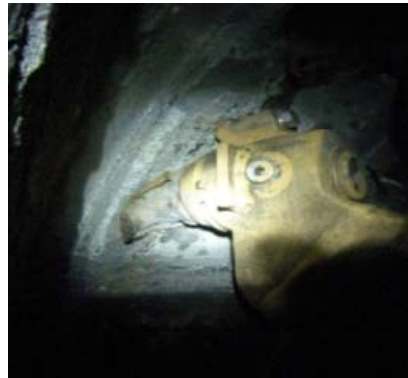
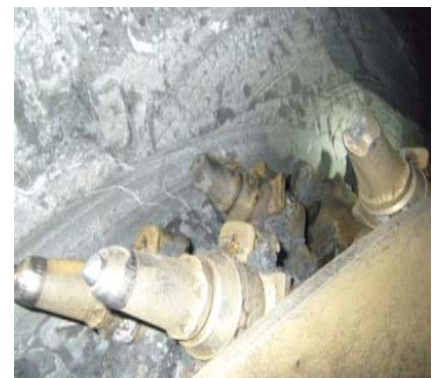
Equipment: Damaged picks, pick sleeves, pick blocks, water sprays (see photos below)
